**THE DENDROCHRONOLOGICAL
DATING OF
TIMBERS FROM THE CHAPEL
PETERHOUSE COLLEGE
CAMBRIDGE**

(TL 448 579)

Author: Dr M. C. Bridge FSA
Oxford Dendrochronology Laboratory
Mill Farm
Mapledurham
Oxfordshire
RG4 7TX

July 2020

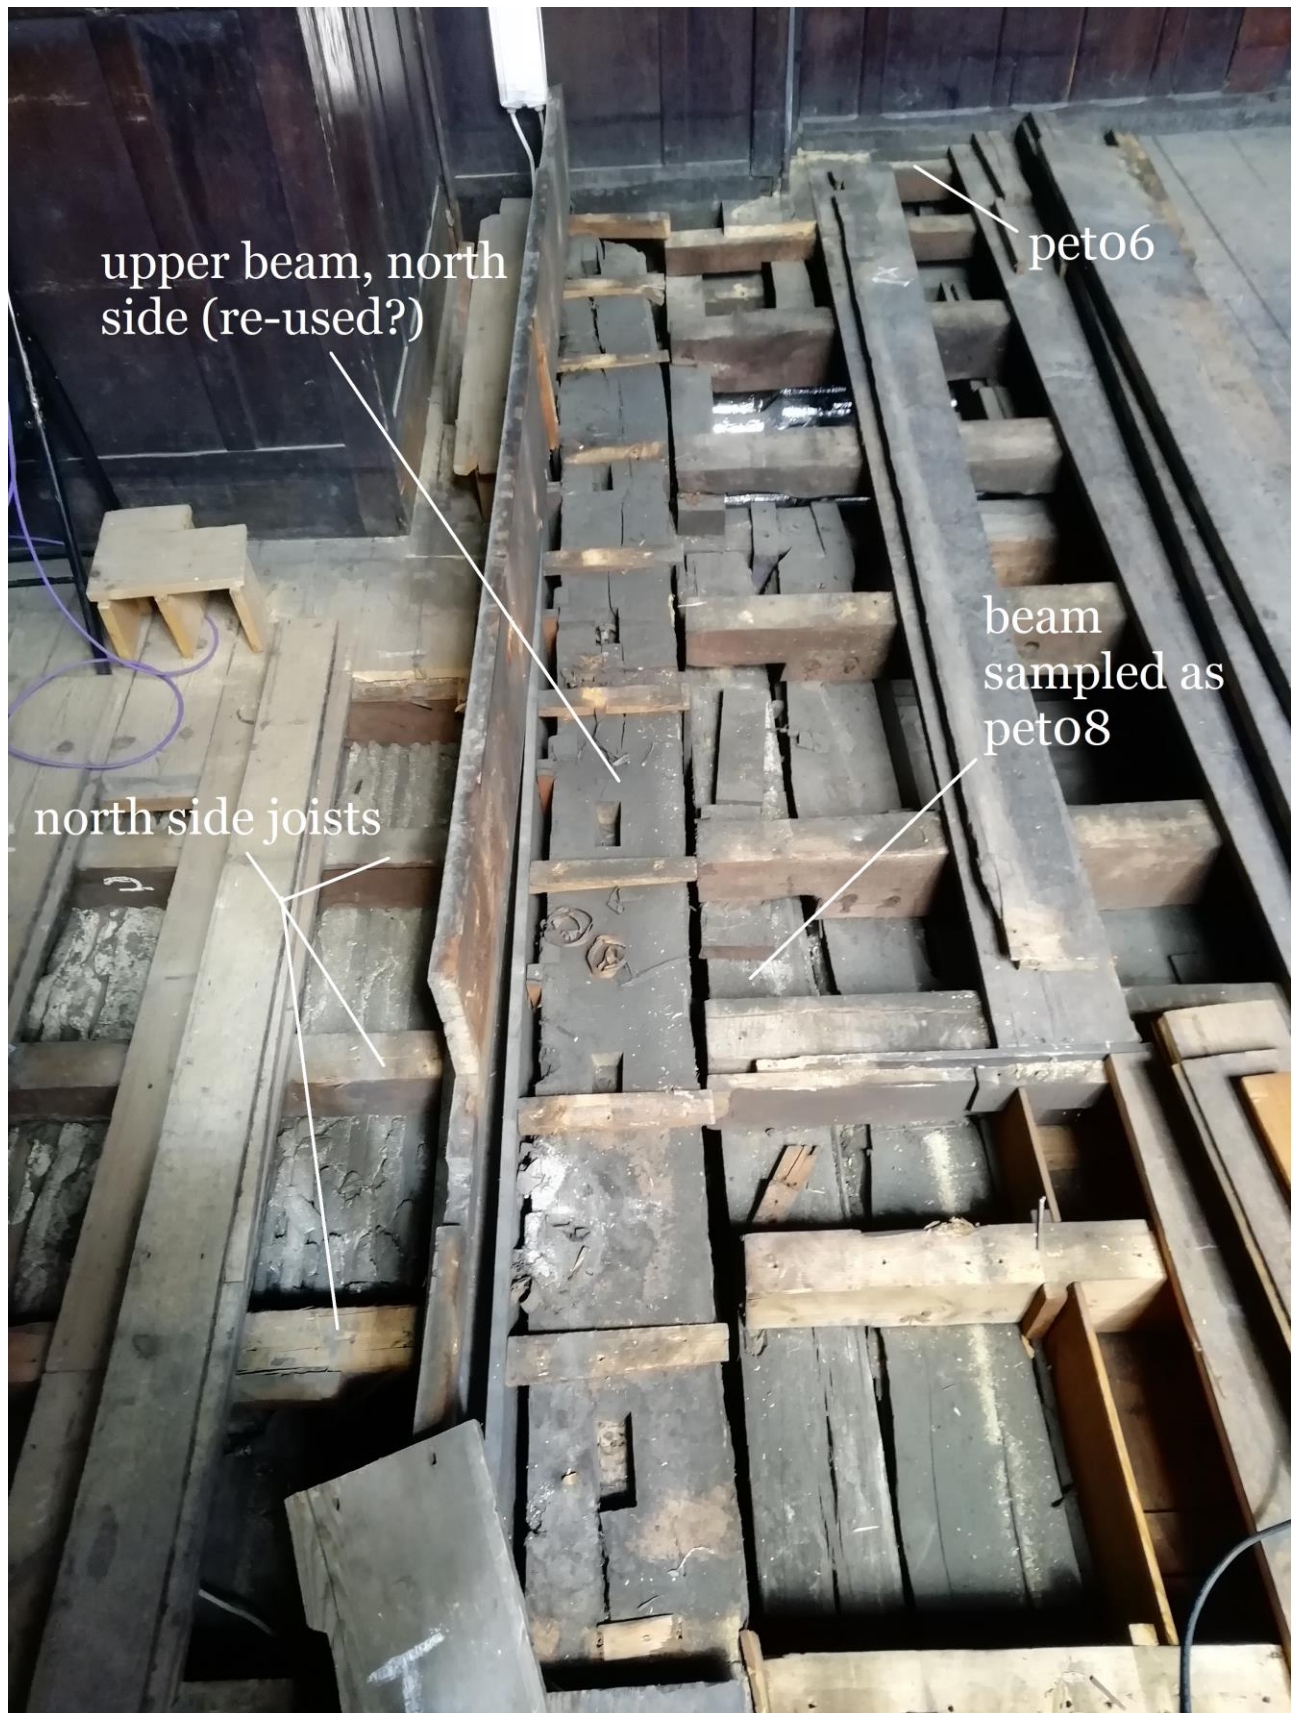
Figure 4: Photograph of the north side of the organ loft (looking east) showing various timbers sampled for dendrochronology and other details

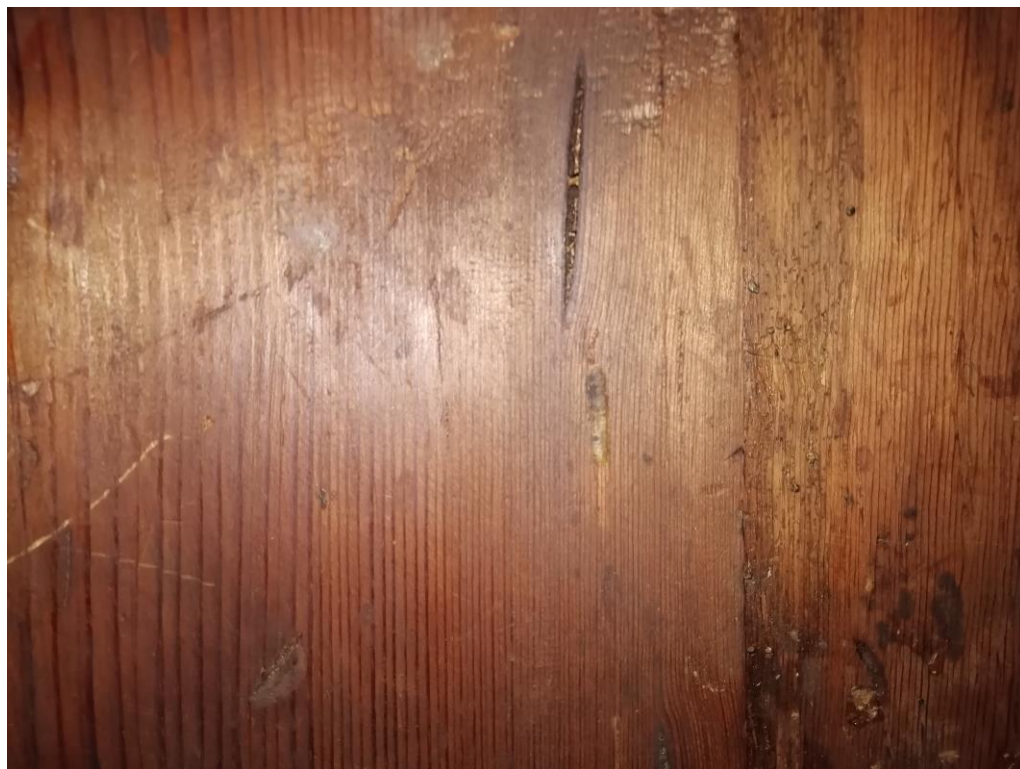
Figure 6: Photograph of the east door leaf of the candle store, showing a pine sequence on the left, and pine with obvious sapwood on the board to the right.

A sequence was measured from a photograph of the inside panel to the east leaf of the candle store. It is particularly difficult to derive a correct sequence from such a photograph, as not all ring boundaries may be obvious, as compared to an end-grain section. The derived sequence did not match any other pine sequence from the site, nor did it match against the database. Since it is possible that ring boundaries were missed, it has not been investigated further. It is interesting that the oak doors to the plant room and candle store appear identical from the outside, but those to the candle store have had reinforcing pine panels added to the inside, presumably reflecting the value of the contents of the store.
